# Appendix A: Project Planning Matrices

Table A-1 . Wilsonville Problem Area Matrix

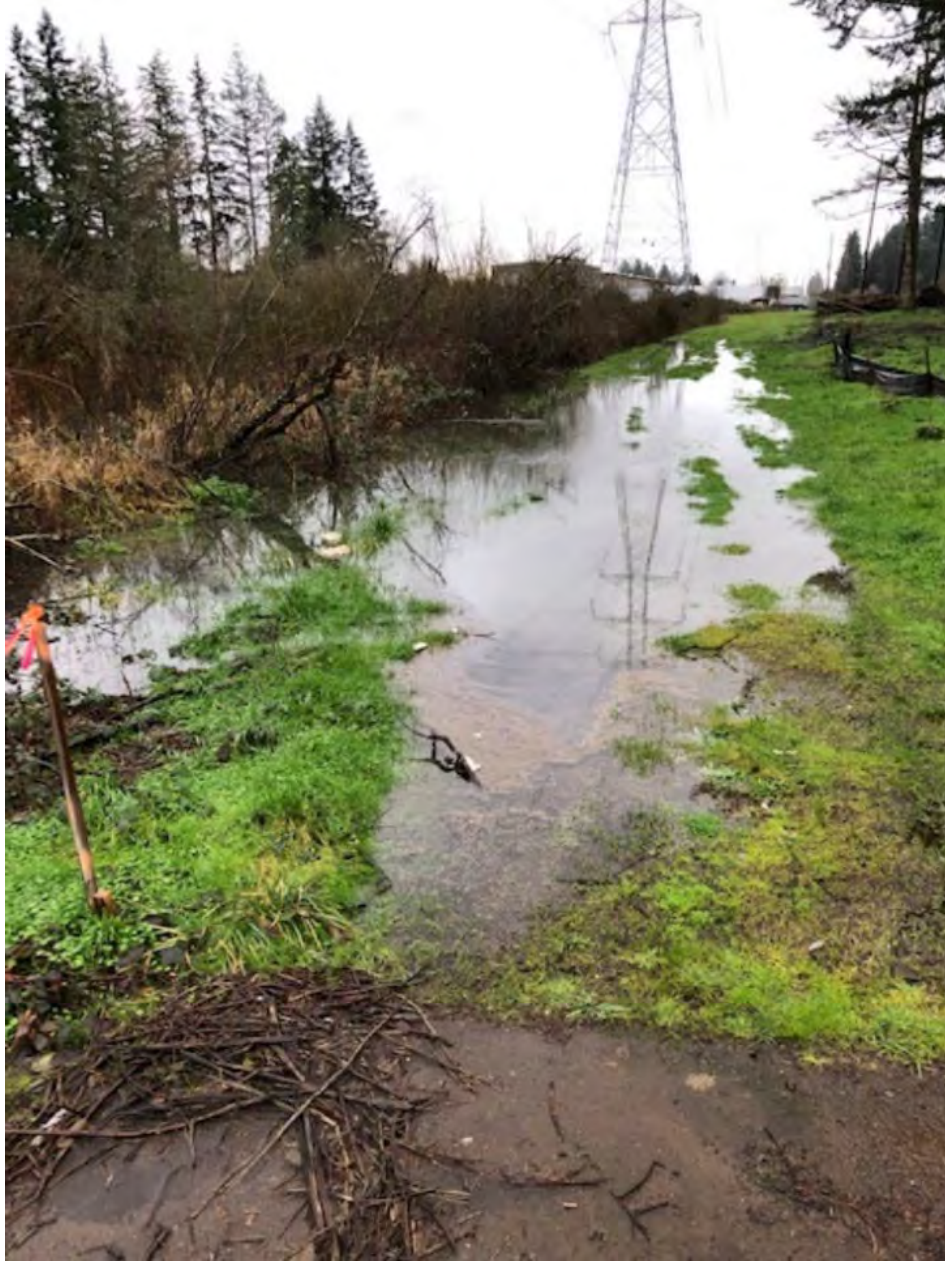
**Figure 1. Validation observations (south of Day Road)**

Public Works staff provided several photographs from January 6 (time unknown) to document the reported ponded water south of Day Road as shown in Figure 1.

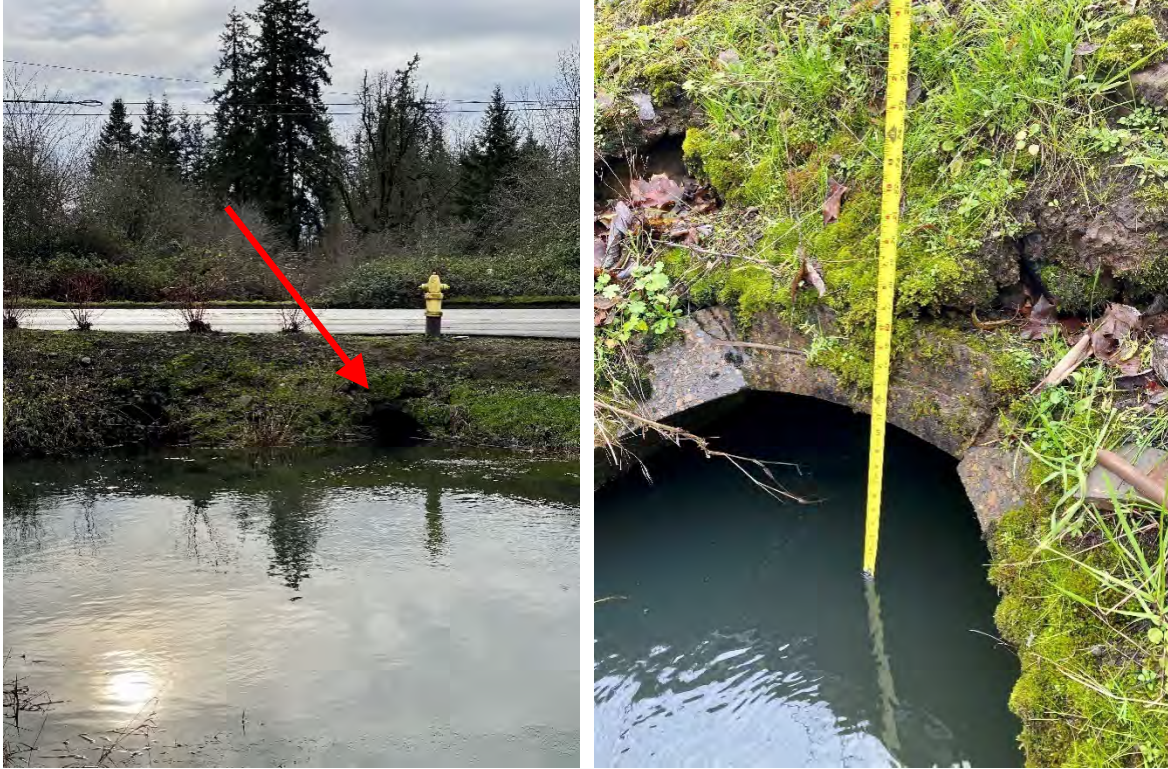
**Figure 2. Validation measurement location (48-in. culvert underneath Ridder Road)**

To correlate observed standing water conditions with measured data, BC staff collected a water depth measurement downstream of the observed flooding per Figure 2 (left) on January 7, 2022 at 11 a.m.. This measurement was collected at one of the 48-inch culverts underneath Ridder Road. While this measurement was collected after the peak of the storm event, water levels within the culvert remained high, as the culvert was approximately 67 percent full as shown in Figure 2 (right) below.

*Left: Location of culvert. Right: Depth of water in culvert.*

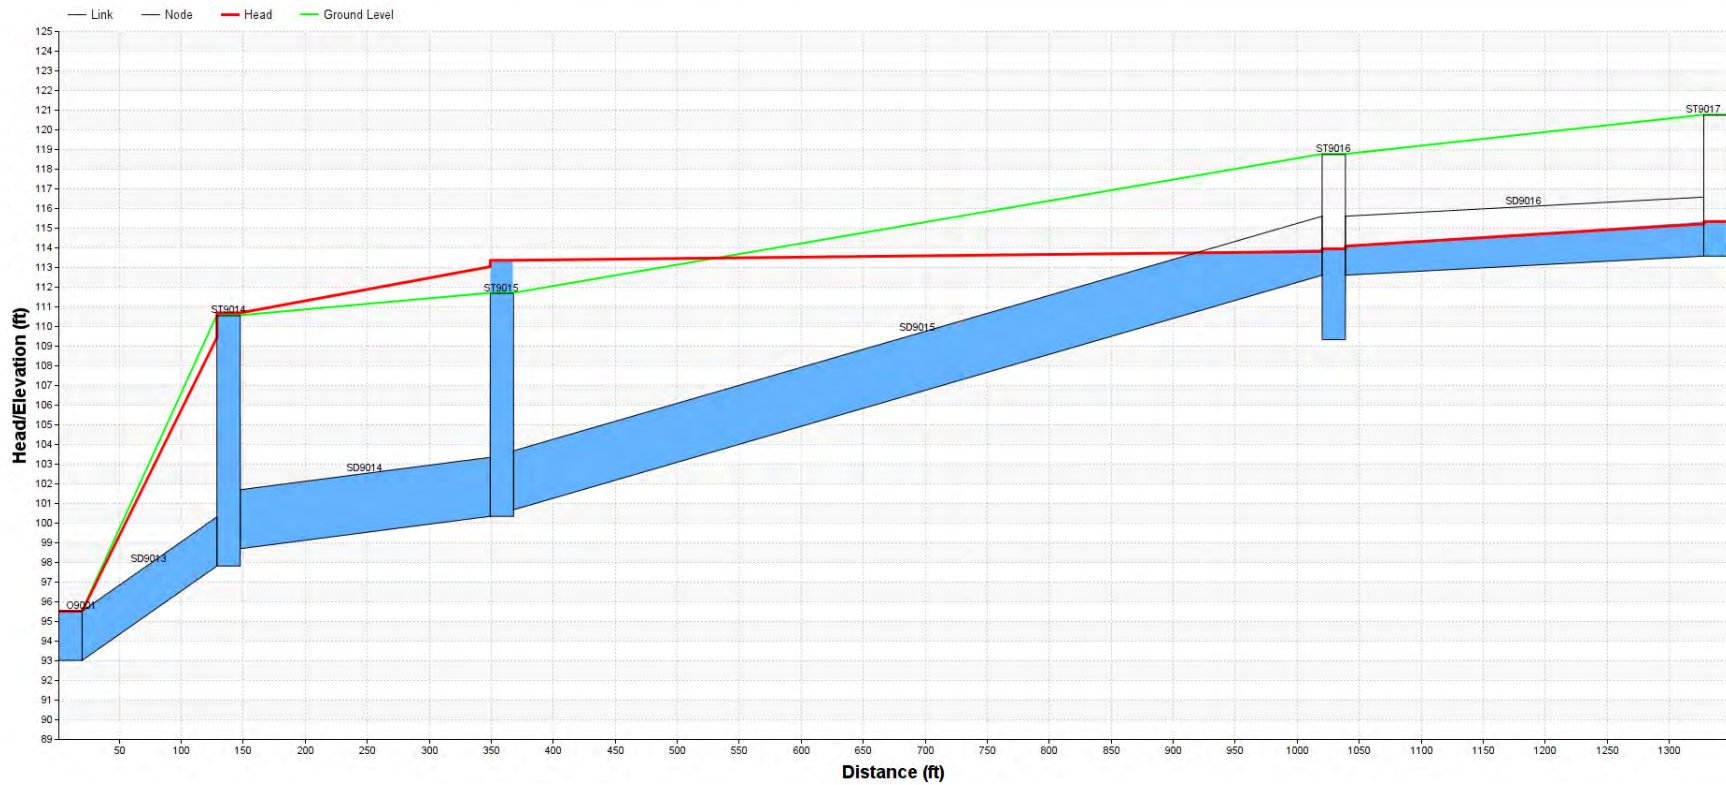
Figure 7. Charbonneau outfall-hydraulic grade line 25-yr design storm

To address predicted flooding, CP development at this location will evaluate options to incorporate detention into the upstream (non-replaced) portions of the collection system, to reduce peak flows downstream. Since available space is limited within the area, concepts that utilize a limited footprint such as detention pipes will be explored.

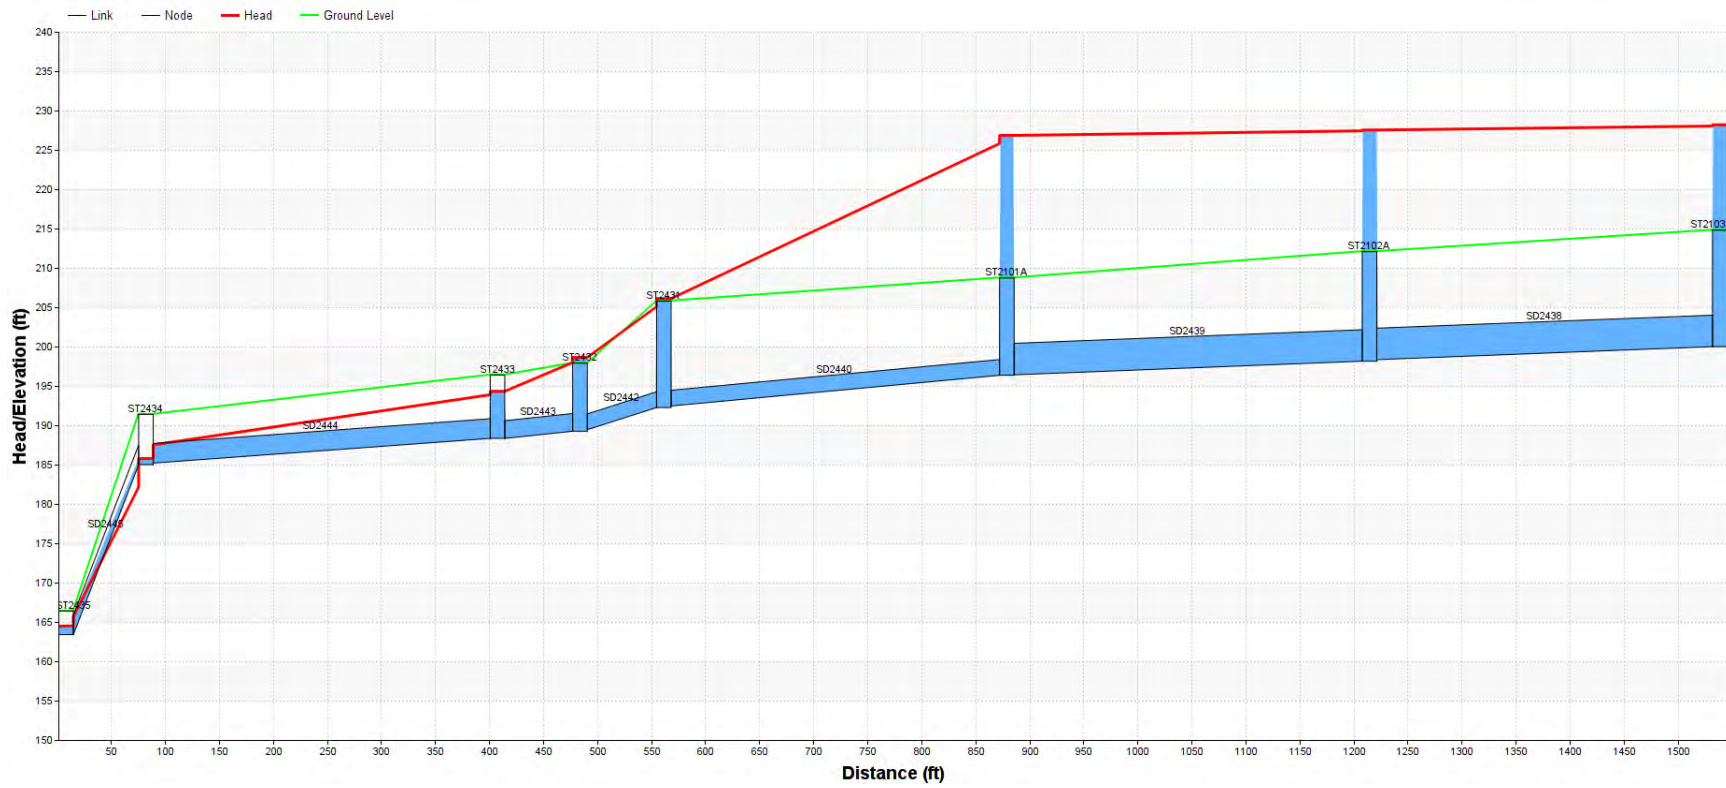
Figure 8. Peters Road-hydraulic grade line 25-yr design storm

This location has several deficiencies within the waterway such as undersized culverts, heavy buildup of vegetation/debris, and segments with negative grade. Historically, this location has been particularly difficult to address due to space constraints, limited available grade, and the original drainage design allowing for the adjacent parking lots to flood to provide detention. This SMP update will build upon previous preliminary design concepts to develop a refined option for implementation.

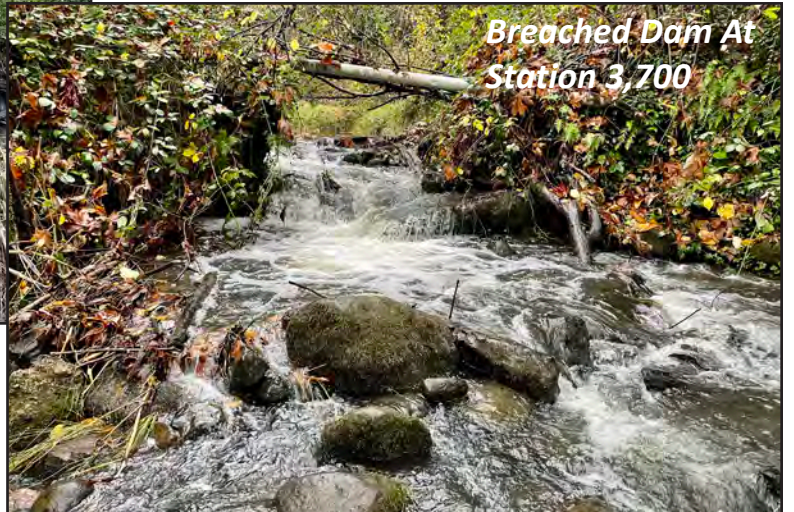
*Breachd Dam At  
Station 3,700*

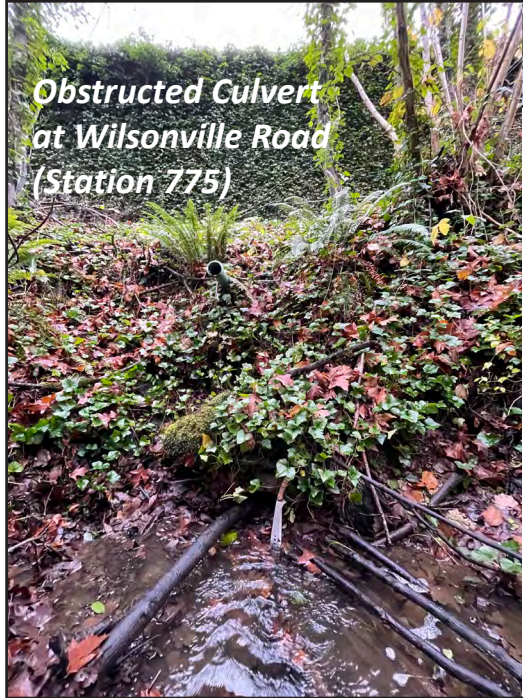
18		Meridian Creek in Landover Park - Reach 1 (US of Wilsonville Rd.)	Meridian Creek	Stream Assessment	Sediment-clogged culvert (30-inch) at the Meridian Creek Crossing at Wilsonville Road. Culvert is mostly obstructed and appears to cause ponding during storm runoff.	MAINT	E&S	Y	Y	N	Y	N	<ul style="list-style-type: none"> <li>Consider location of ponding and whether infrastructure is being impacted.</li> <li>If ponding is isolated to park and not overtopping any roadways or impacting private property, then maybe this isn't a problem that needs to be fixed. It's effectively a detention pond.</li> <li>Per Wksp 3-15, planning project need to monitor location and confirm worsening.</li> </ul>	Y-City-2	N	Y-P-5	N
19		Meridian Creek in Landover Park - Reach 2 (DS of Willow Creek Dr.)	Meridian Creek	Stream Assessment	Culvert outlet at upstream end of reach is clogged and backs up water underneath Willow Creek Dr. PVC SW outfall along reach is undermined (STA 1,100) and 6-foot section has washed out and moved downstream.	MAINT	E&S	Y	Y	N	Y	N	<ul style="list-style-type: none"> <li>Need in-water work permits to replace culvert.</li> <li>Traffic impacts to Willow Creek Drive during culvert replacement.</li> <li>Per Wksp 3-15, planning project need to monitor location and confirm worsening.</li> </ul>	Y-City-2	N	Y-P-5	N

*Close Up of Obstructed  
Culvert at Wilsonville Rd*

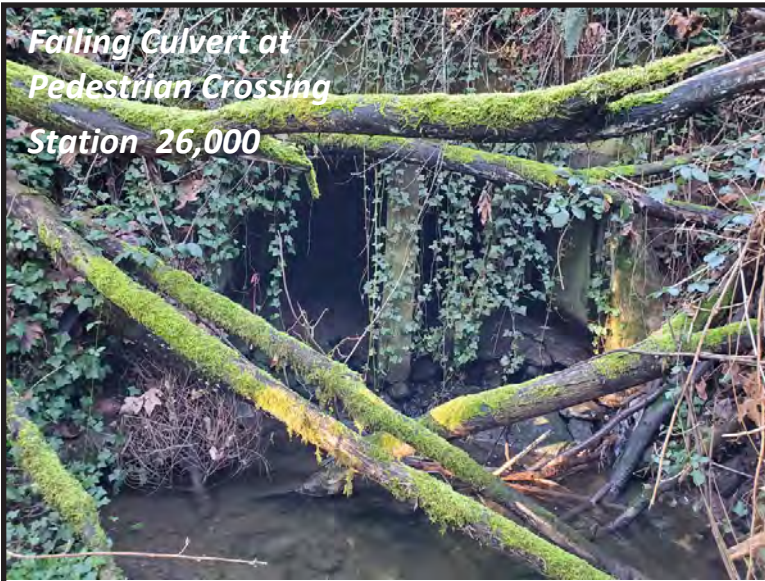
20		Arrowhead Creek at Pedestrian Bridge (Reach 4)	Coffee Lake Creek	Stream Assessment	Culvert at upstream end of reach (at pedestrian crossing) is failing and should be considered for replacement.	R/R		Y	Y	N	Y	N	<ul style="list-style-type: none"> <li>Need in-water work permits to replace culvert.</li> <li>See Project Opportunity #14.</li> </ul>	Y-CLC-2	N	N	N
21*		Memorial Park (Swale Retrofit, Pipe Upsizing, and Mitigation)	Boeckman Creek	Retrofit Analysis H/H Model	Swale at Memorial Dr. is not draining properly. Potential concept is to extend swale all the way along the road or relocate to the base of hill. Modeling evaluation indicates that the pipe system after convergence point at Memorial Drive has a constriction resulting in backwater and upstream system flooding (preliminary flooding location #5).	MAINT	CAP	Y	Y	Y	N	Y	<ul style="list-style-type: none"> <li>Opportunity to expand water quality treatment through retrofit of existing facility.</li> <li>Location is also affiliated with Boeckman Road mitigation alternative location (raising of pedestrian trail to detain flow from entering Boeckman Creek).</li> <li>Relocation of swale allows for offline facility construction.</li> </ul>	Y-BC-5	--	N	N

4	19+50	26+00	Stable reach with hardpan grade control. Culvert at upstream extent of reach is in the process of failing	1.31%	plane bed meandering	hardpan bedrock gravel	incised but stable	shallow alluvium intermittent on hardpan bedrock	valley walls ~25-ft high with low energy	N	stable	1	2	2	2	Ivy removal and riparian restoration	Subreach consists of 50'-75' valley bottom confined by 25'-30' of 1:1 valley walls. Channel incised 2'-5' into valley bottom with some active inset floodplains. Creek flows on hardpan bedrock. Cottonwood/alder/fir canopy threatened by ivy which dominates groundcover.

*Falling Culvert at  
Pedestrian Crossing  
Station 26,000*

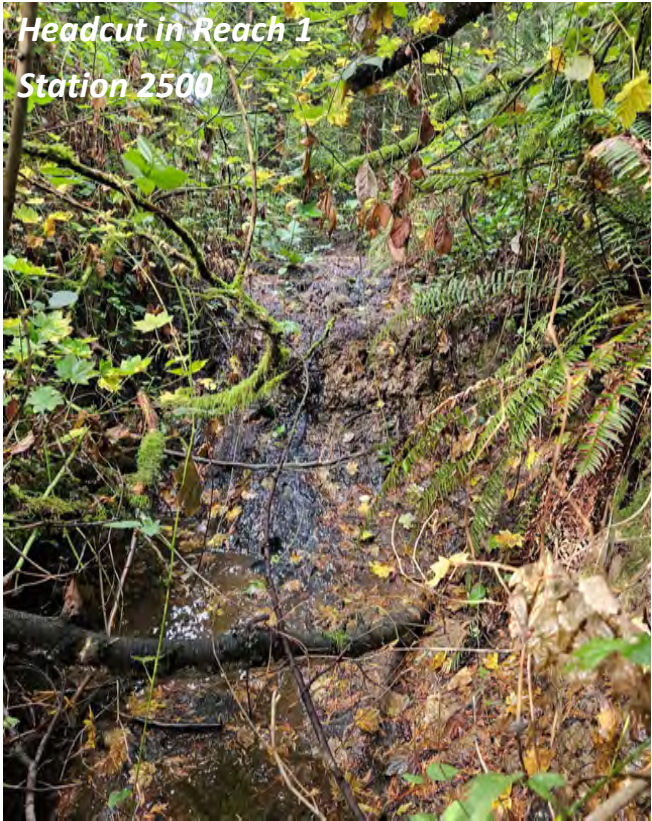
*Headcut in Reach 1  
Station 2500*

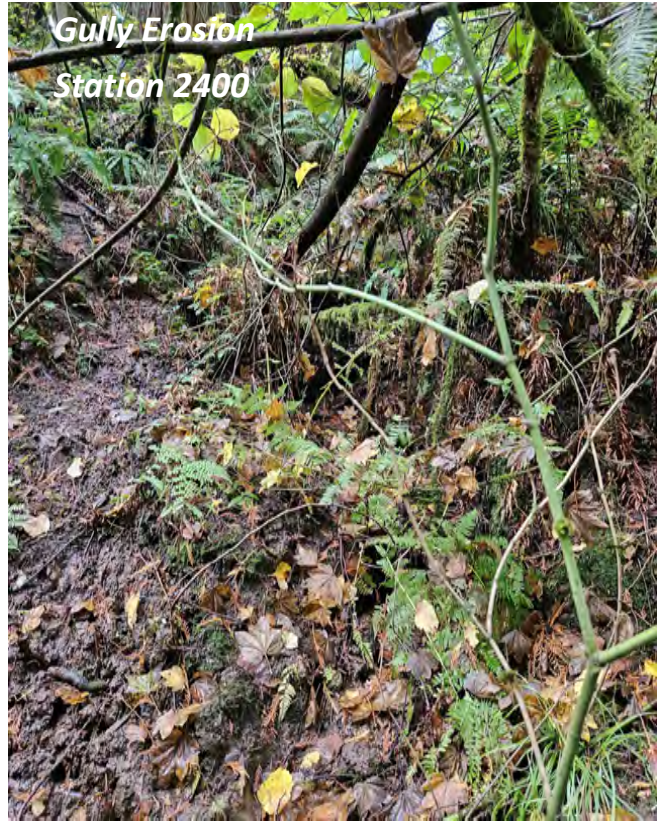
*Gully Erosion  
Station 2400*
