MEMORANDUM

RE: New Commercial Development on SW Parkway Avenue, Wilsonville, OR

City of Wilsonville
Exhibit B5 DB24-0006

TONKIN LAMBORGHINI
3S-1-32DA TAX LOT 1000, SW PARKWAY AVE
WILSONVILLE, OR 97070

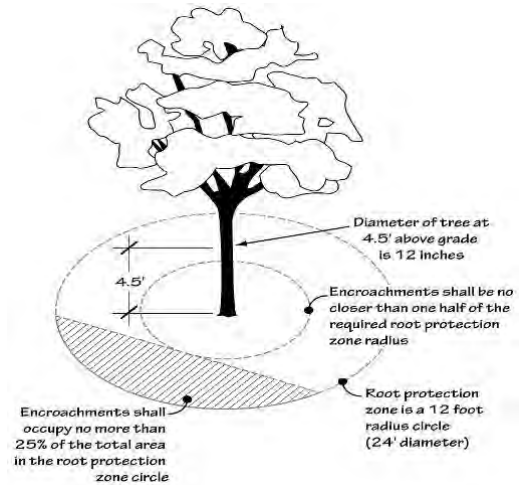
Figure 1: Typical minimum protection zone

A typical minimum root protection zone allows encroachments no closer than a radius from a tree of 0.5 feet per inch of DBH if no more than 25 percent of the root protection zone area (estimated at one foot radius per inch of DBH) is impacted. Figure 1 illustrates this concept. This standard may need to be adjusted on a case-by-case basis due to tree health, species, root distribution, whether the tree will be impacted on multiple sides, the specific development proposed, and other factors.

Sediment control fencing will be placed between the proposed development and the wetland. Tree protection fencing will be placed in conjunction with sediment fencing to protect the trees in closest proximity to development. This includes trees 3, 12–16, and 40, which are in closest proximity to the proposed development. The location of fencing is depicted in the site plan map included as Attachment 2. The only tree that would have a notable encroachment into the typical root protection zone is tree 3, a 24-inch DBH Norway spruce (*Picea abies*). A new stormwater facility and water meter installation would be installed near that tree, but not within the minimum protection zone.

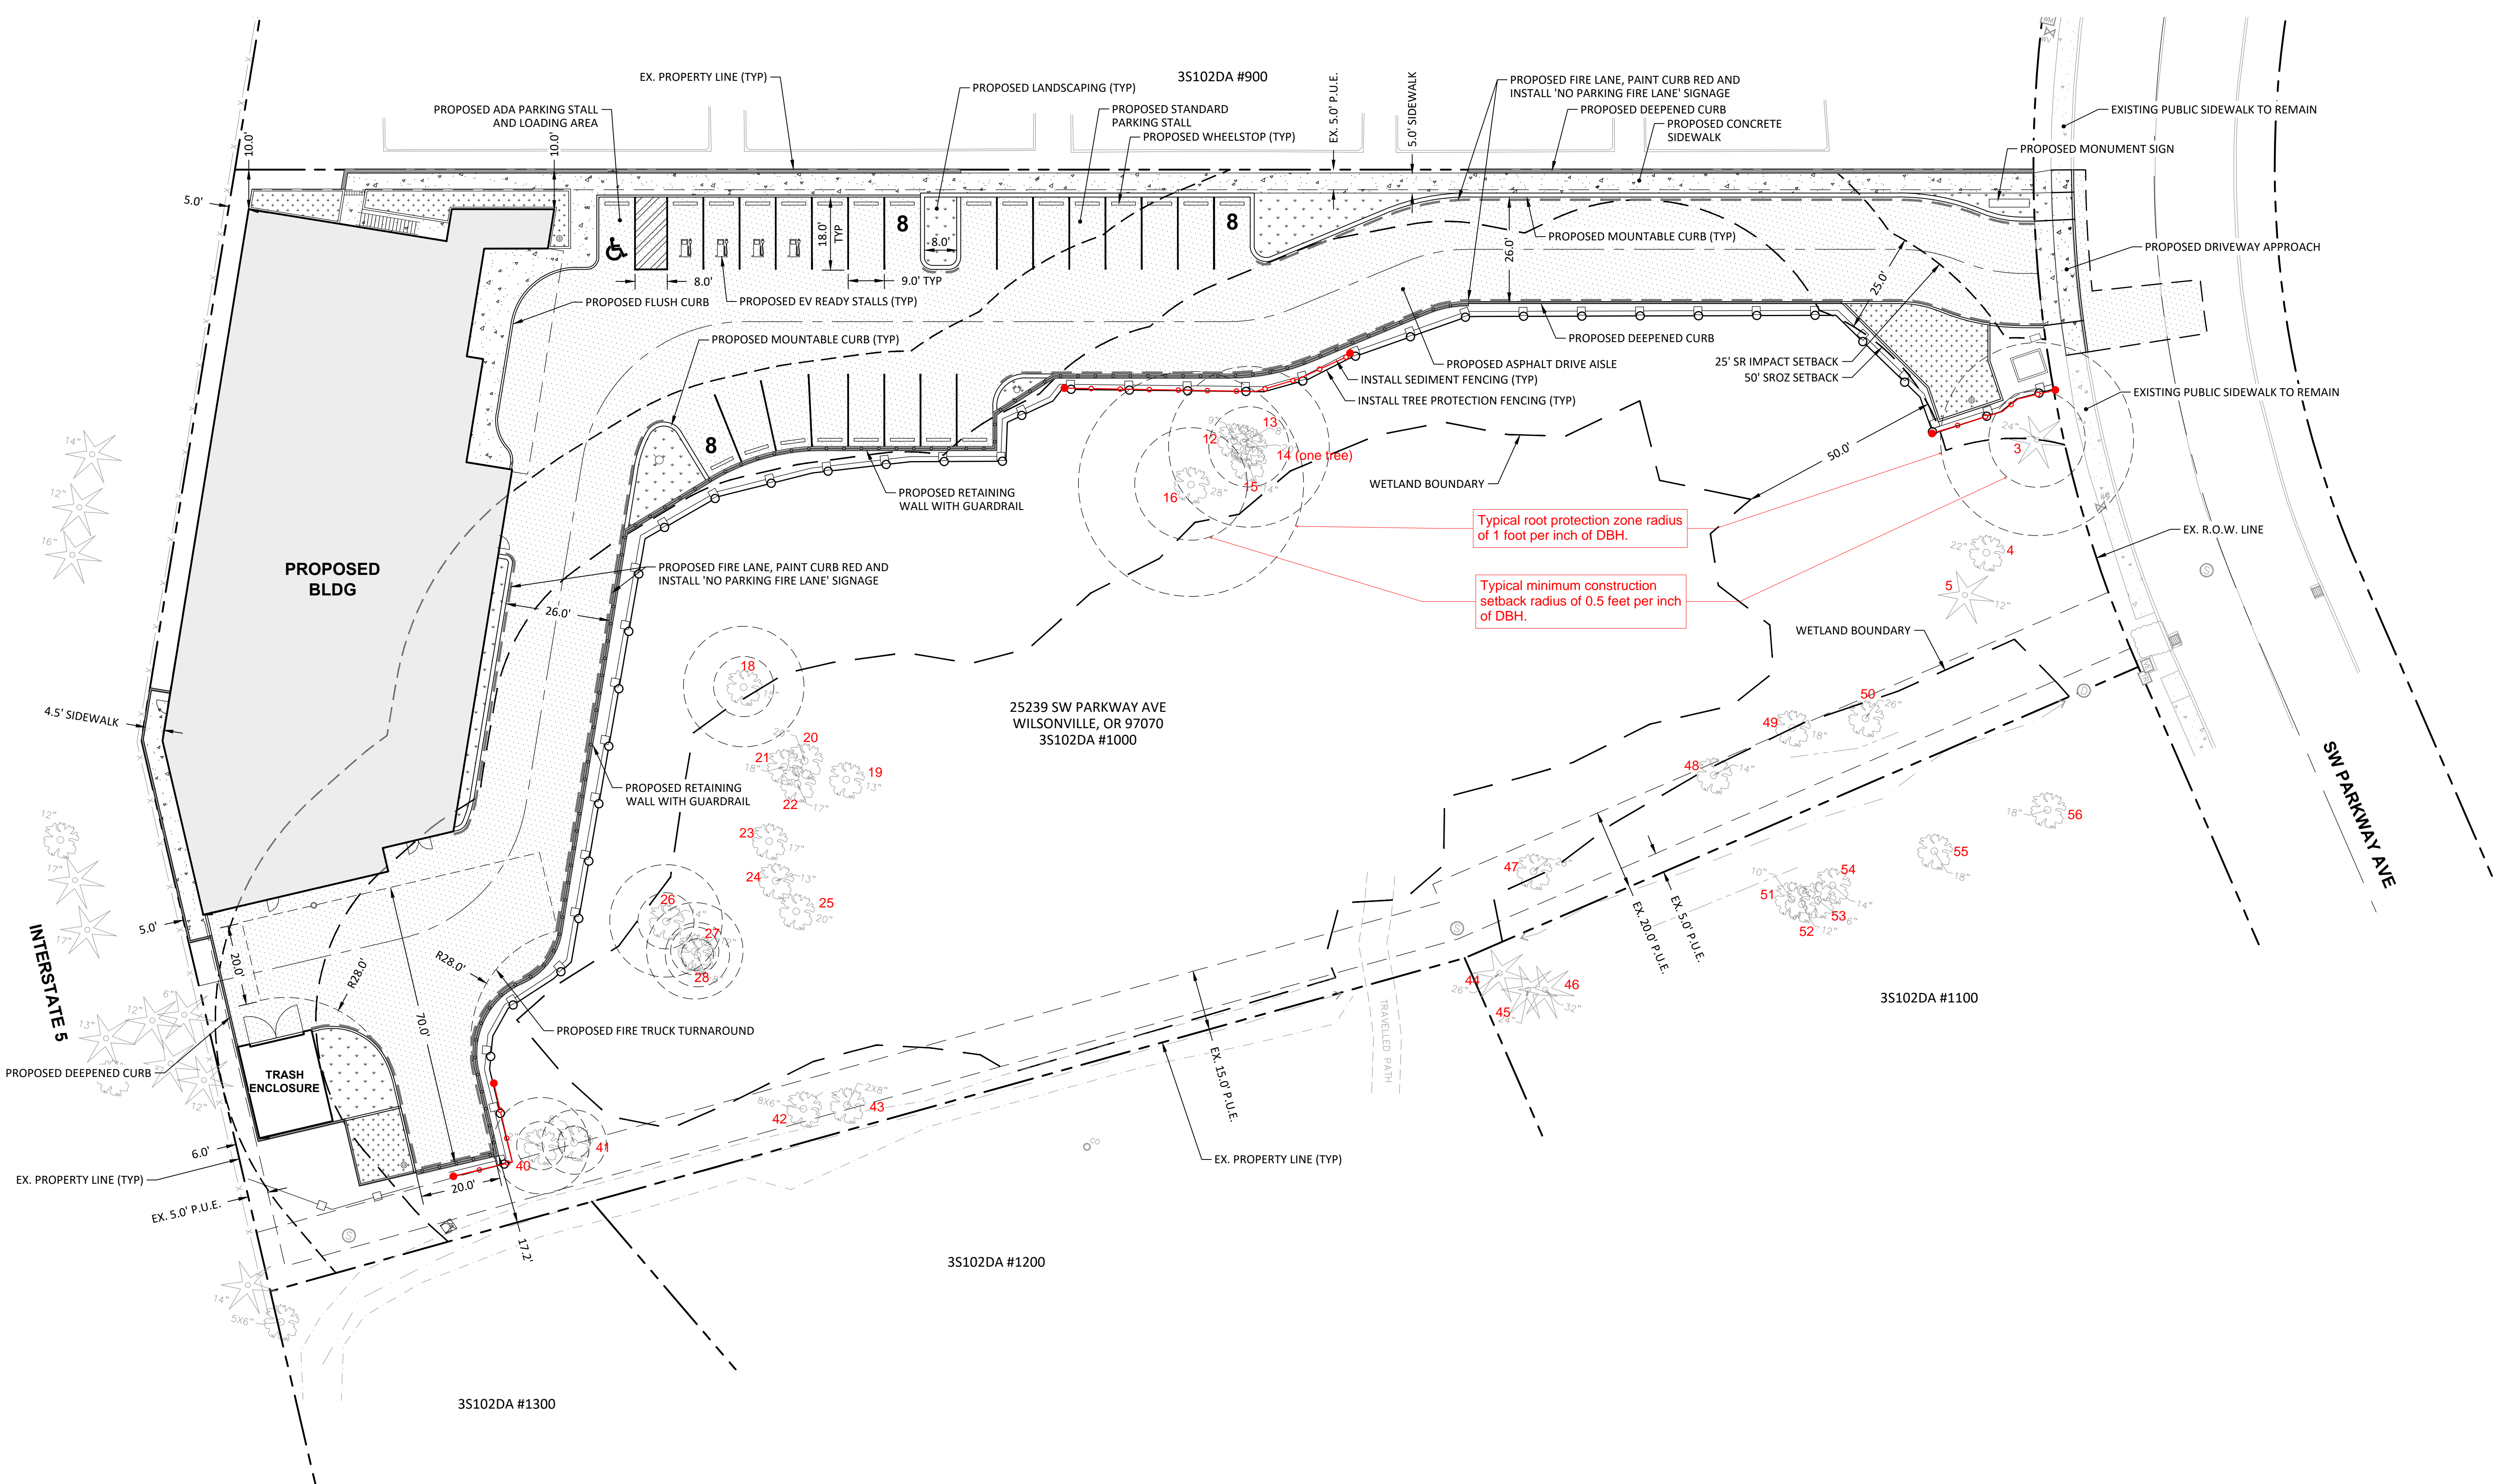
Typical root protection zone radius of 1 foot per inch of DBH.

Typical minimum construction setback radius of 0.5 feet per inch of DBH.

DRAWN BY: HHPR
 CHECKED BY: HHPR
 JOB NO: 22-033
 DATE: 10/04/2024
 ISSUED FOR: PRELIMINARY
 SHEET TITLE: PRELIMINARY CIVIL SITE PLAN

- d. *Locations:* Install fencing as shown in Attachment 2.
 - e. Tree protection fencing shall not be moved without written approval from the project arborist.

- f. A tree protection fencing detail is on the tree protection plan (Attachment 2).
2. **Tree protection signage.**
 - a. Weatherproof tree protection signage shall be placed on tree protection fencing.

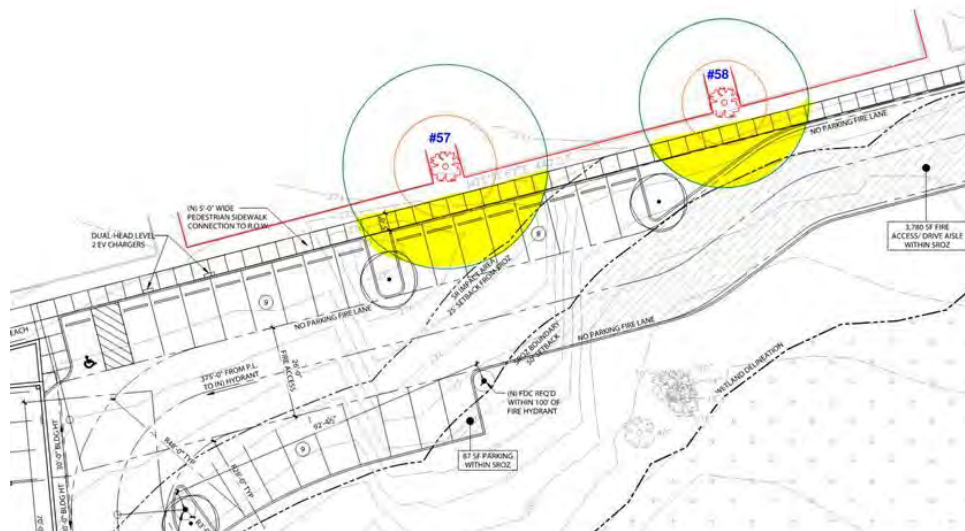
With regards to the two large trees at our south property line (#57 & #58 on the graphic below), which overhang the development site, I hereby give permission for Casa Tonchinni LLC to remove the indicated trees and replace them with new smaller trees of a similar type, at their expense.
