# Appendix A: Project Planning Matrices

Table A-1 . Wilsonville Problem Area Matrix

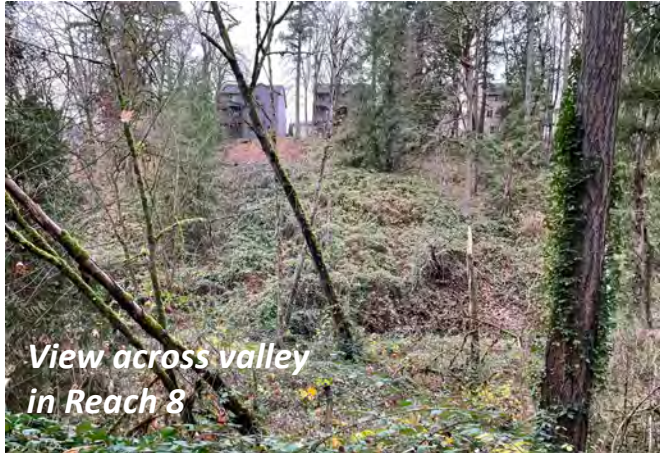
*View across valley  
in Reach 8*

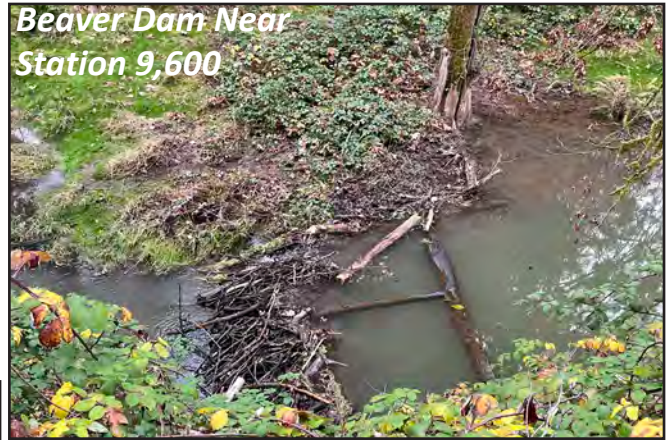
*Beaver Dam Near  
Station 9,600*

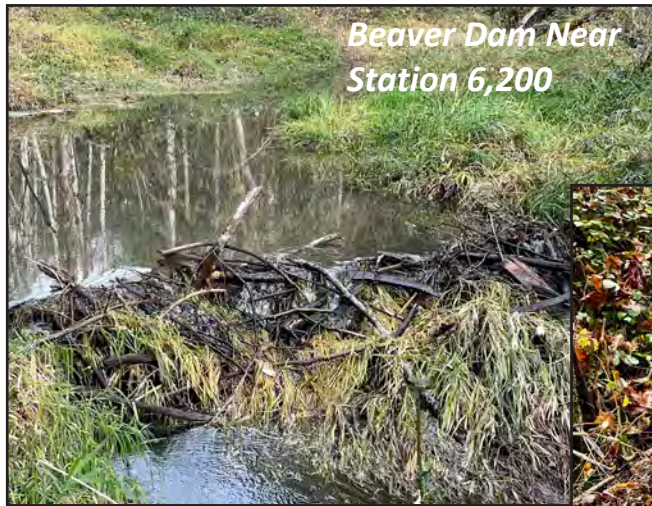
*Beaver Dam Near  
Station 6,200*

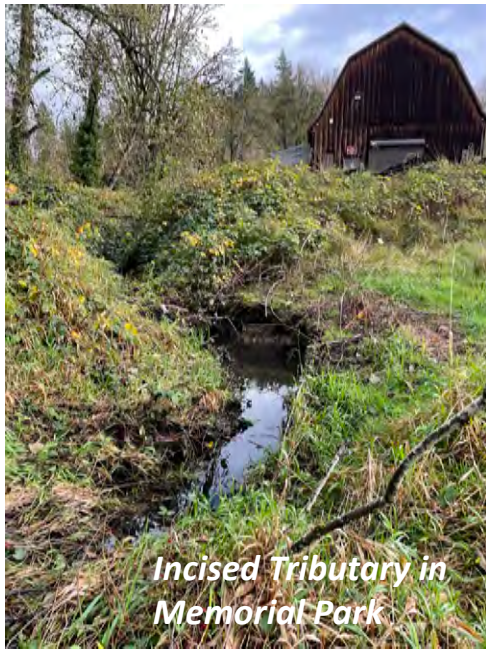
- The downstream tributary enters Boeckman Creek on river-right through a culvert under a road crossing in Memorial Park. The lower section of this tributary is deeply incised, low-gradient, gravel- and sand-bed stream in a dense blackberry thicket. Some bank erosion was observed along the steep banks but was not identified as an infrastructure concern. There is a partially clogged culvert on this tributary at a road crossing several hundred feet upstream of the confluence with Boeckman Creek. The clogged culvert backs water up to a footbridge in a grassy field in the park but does not appear to have any detrimental impacts. More descriptions are provided in **Appendix A1**, and photographs of this tributary can be found in the photo log (**Figure 10a**).

*Incised Tributary in  
Memorial Park*

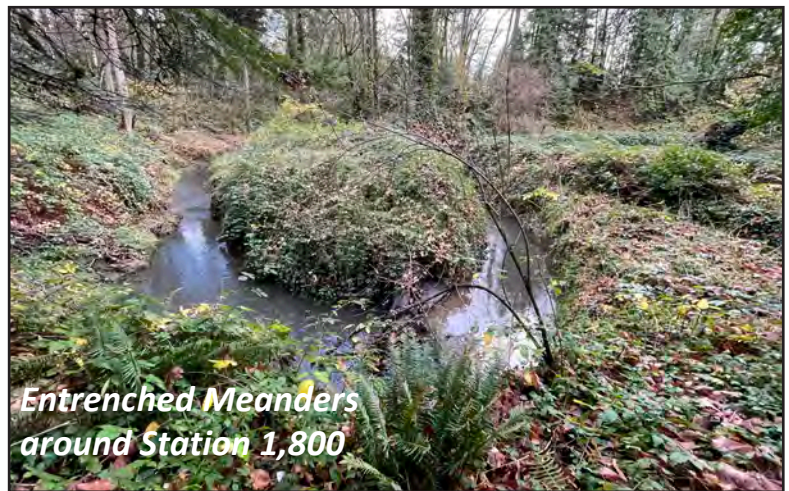
*Entrenched Meanders  
around Station 1,800*

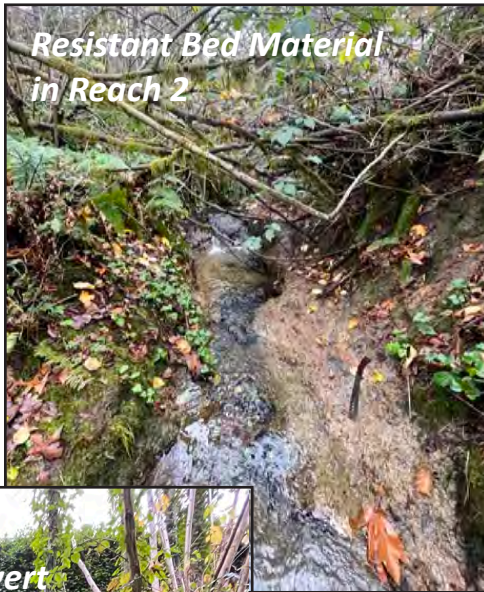
- The PVC stormwater outfall on the creek at Station 1,100 is undermined and a 6-foot section has washed out and moved downstream.

*Undermined Outfall at  
Station 1,100*

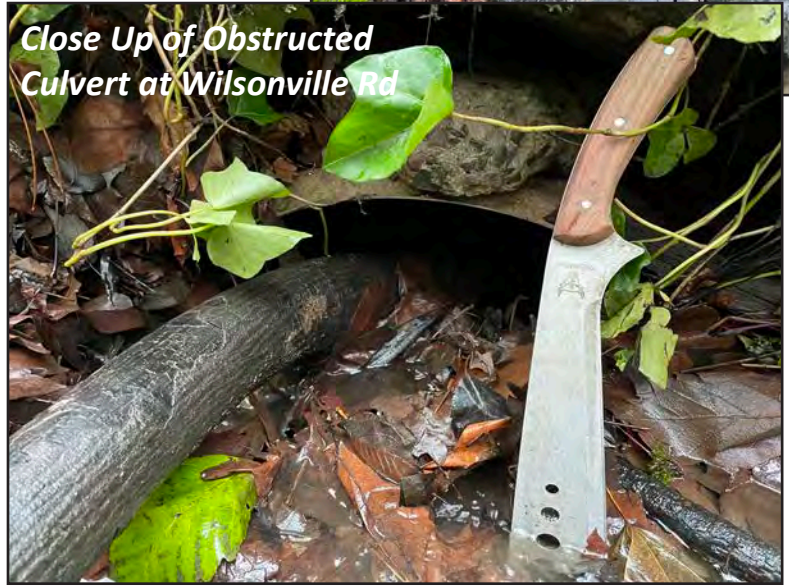
*Close Up of Obstructed  
Culvert at Wilsonville Rd*

The primary infrastructure issue in this reach is the crossing of Meridian Creek under Wilsonville Road (**Figure 11; Photos on Figure 13**). The culvert appears to be undersized and is nearly clogged with fine sediment. This obstruction caused a wedge of sediment to accumulate in the channel upstream. The lack of drainage appears to cause some ponding under current conditions, and complete plugging of the culvert seems like a reasonable possibility. It is unlikely that ponded water would overtop Wilsonville Road, but repeated ponding behind the road could cause geotechnical instability through other

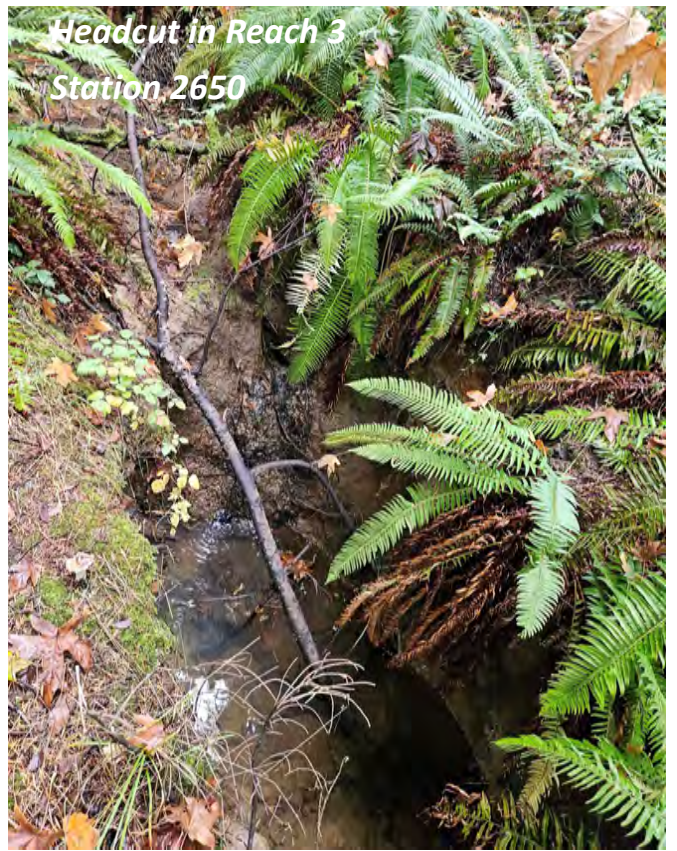
*Headcut in Reach 3  
Station 2650*

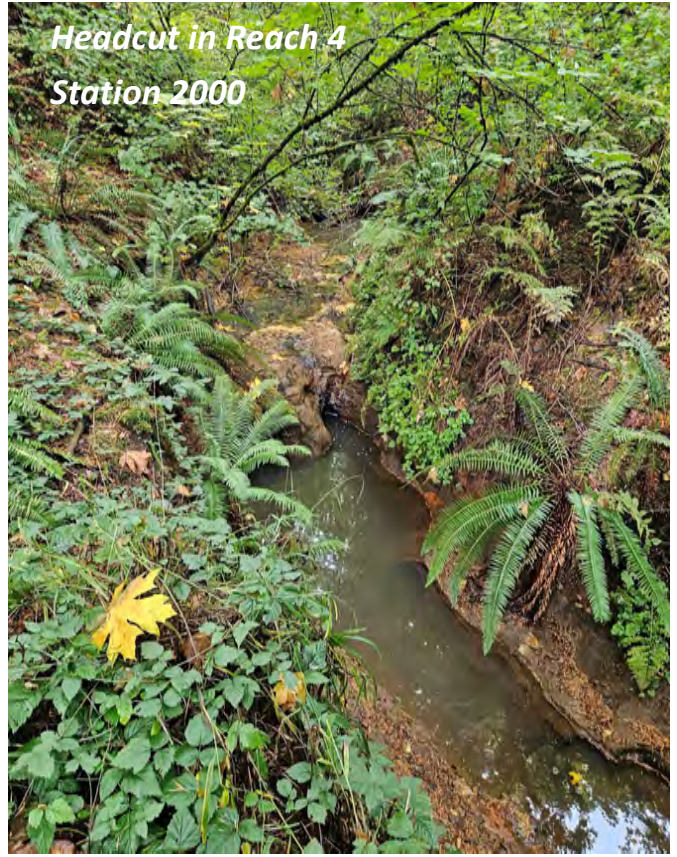
- Only one large headcut was observed in Reach 4. This reach may be in a widening phase in response to past incision as more bank instability was observed.

*Headcut in Reach 4  
Station 2000*

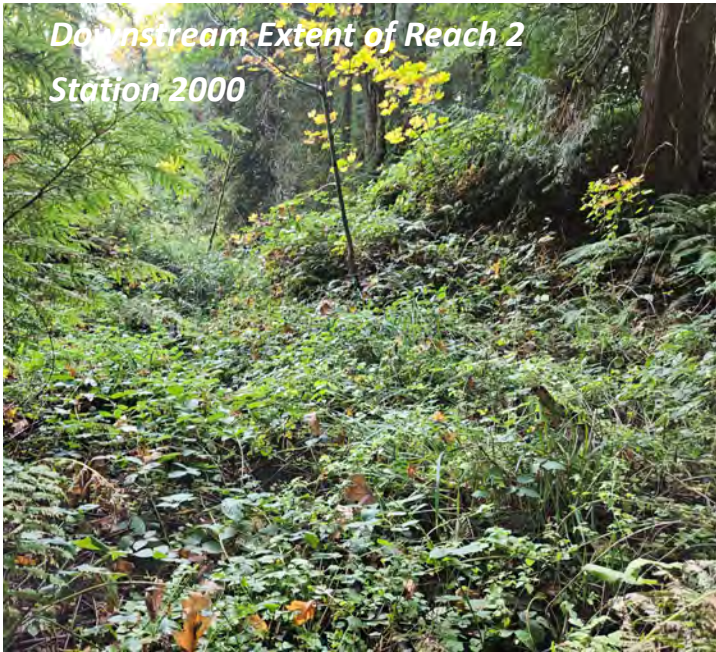
*Downstream-Extent of Reach 2  
Station 2000*

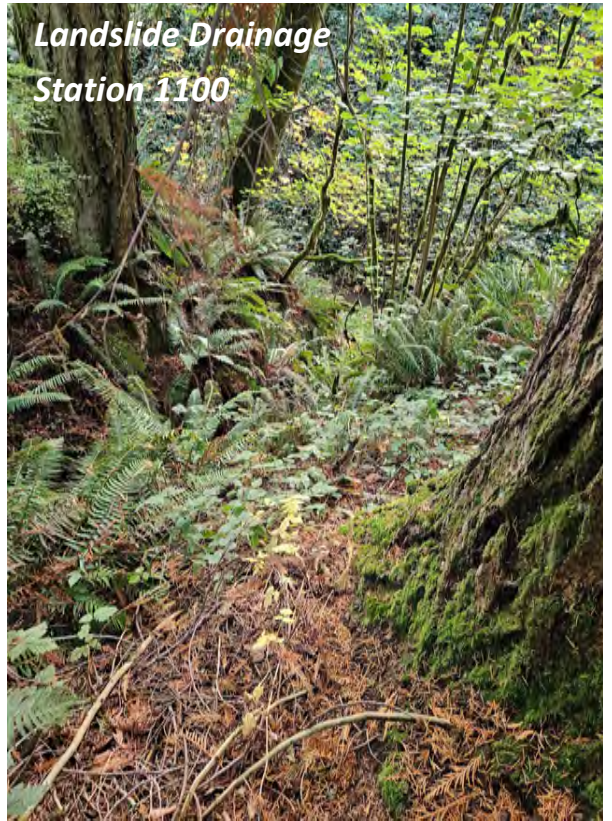
*Landslide Drainage  
Station 1100*

15+00	PM 6					right spring fed											Drainage from landslide area enters from right bank. Flow equal to or exceeds main channel flow. Flow is piping through landslide along bank.
11+00	PM 7					left spring fed											Tributary or drainage input from left bank. Might be from landslide. Steep drainage. Could be highly erosive if additional water is delivered to the drainage.
